# Safety Alert - Swing-Up Stabilisers

October 2021

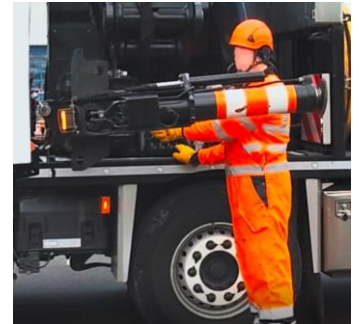
Operator stowing swing-up stabiliser using levers at the crane base

- Swing-up stabilisers should be pinned / locked in the vertical / upright position before the stabiliser beam is deployed or retracted.
- It is essential that Operators fully observe the operation of the stabiliser leg during deployment and stowage.

- Operators must be made aware that the operation of the swing-up function must be separate from the movement of the stabiliser beam (i.e. they should not use both functions simultaneously).

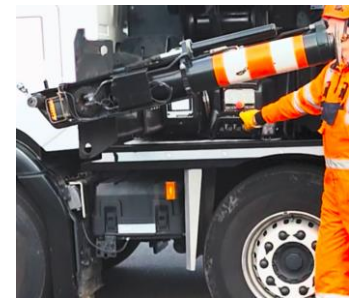
Location of levers at the crane base
